Product Campaign Bulletin

REFERENCE: PCB-NES-16-026

MODEL: J11 Qashqai

SUBJECT: PCB J11 - PG6BB - Nissan Connect Digital Audio PDI Reprogram

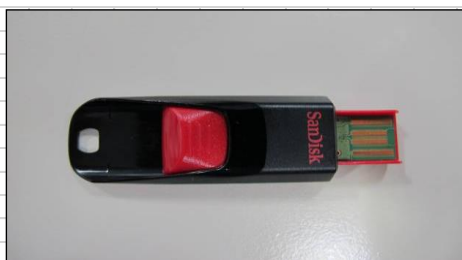
- 1 Following the process indicated in the appendix at the end of this procedure download the required software onto a USB Memory stick.

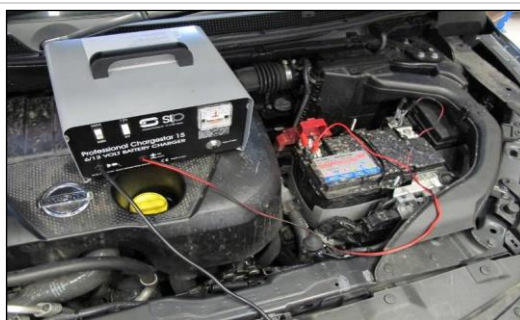
- 2 Open the hood of the vehicle. Locate and connect a battery charger / leveliser to the vehicle battery. Ensure the battery charger / leveliser is ON and functioning.

CARE POINT: The physical reprogramming update of the Nissan Connect unit takes roughly 50 minutes. It is extremely important to connect a battery charger / leveliser to the vehicle battery. If the reprogramming procedure fails due to flat battery, the Nissan Connect unit will not be recoverable.

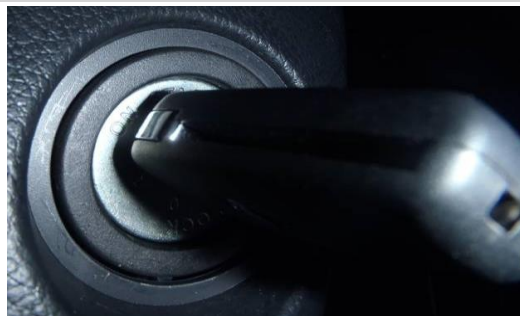
- 3 For non i-Key vehicles insert the key into the ignition barrel and turn clockwise 1 stop to Ignition ON mode.

For i-key vehicles press the start / stop button once to enter Ignition ON mode.

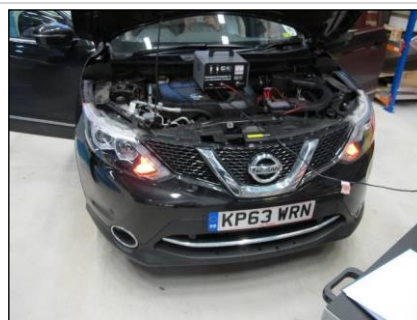
- 5 Lower the driver's window to the down position.

Press the hazard light switch to ON position and ensure the hazard lights are activated.

CARE POINT: The physical reprogramming update of the Nissan Connect unit takes roughly 50 minutes. It is extremely important to activate the hazard lights. This prevents the Nissan Connect unit shutting down due to its power save feature.

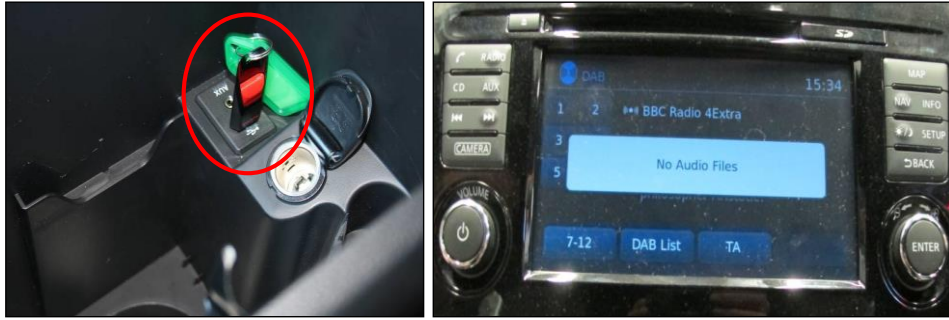
- 6 Insert the USB Memory Stick into the USB Slot located in the centre console storage compartment.

A message may appear but not necessarily on the Nissan Connect screen stating 'No Audio Files'.

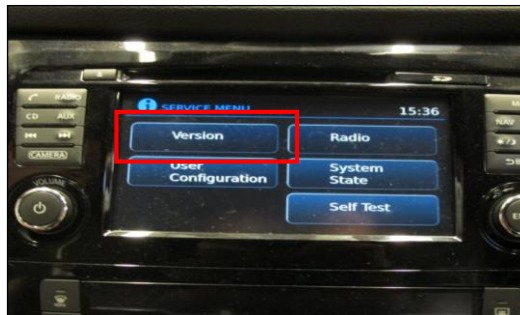
- 8 Press the 'Version' button on the Nissan Connect screen.

The 'Service Version' screen will appear.

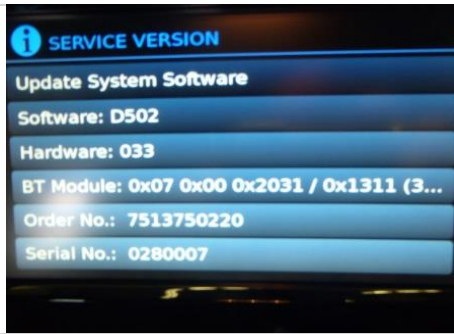
- 10 Press the 'Update System Software' button.

A message will appear stating "Insert USB stick and press OK to start software download. Do not interrupt download by removal of USB drive or engine start". With the ignition still on and the hazard lights still flashing.' Press 'OK'.

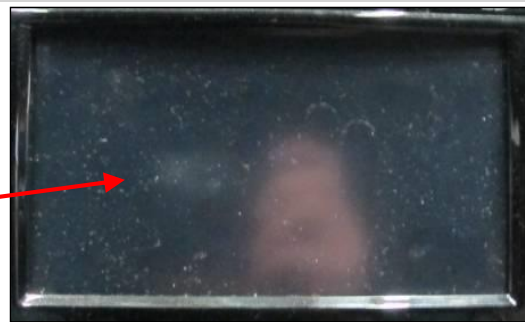
- 11 The 'Application' screen will now appear and will state 'Download Media Found'.

Press the 'Update' button on the Nissan Connect screen.

CARE POINT: The Nissan Connect screen will now go blank. This is normal - the Nissan Connect unit is initialising the reprogramming process. Do not remove the USB memory stick or alter the ignition position.

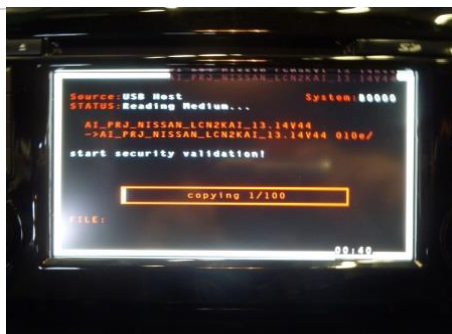
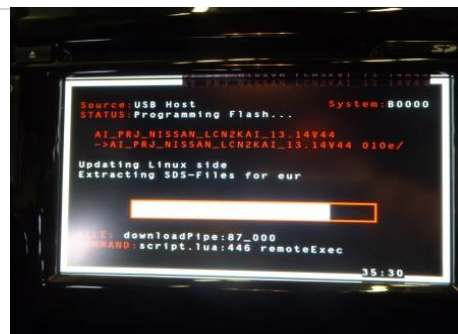
- 12 After a period of up to 5 minutes, the Nissan Connect screen will become active and a 'Reading Medium' message will appear.

The reprogramming files will begin copying from the USB Memory Stick to the Nissan Connect unit.

A time elapsed counter will appear in the bottom right corner of the screen (highlighted below in red).

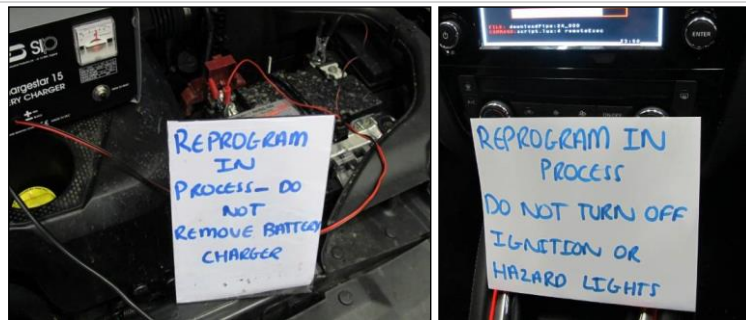
- 14 **CARE POINT:** It is extremely important the Nissan Connect unit reprogramming update is not interrupted. If the reprogramming procedure fails due to flat battery or due to the Nissan Connect units' power down function, the Nissan Connect unit will not be recoverable.

During the reprogramming update, ensure the vehicle is labelled sufficiently so no other staff member tampers with the vehicle setup.

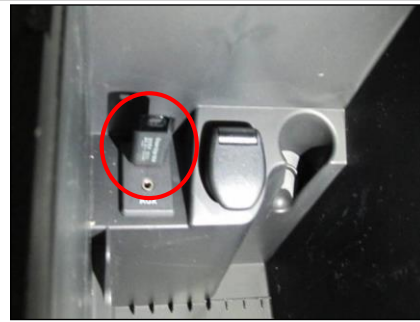
- 15 After the reprogramming update has finished a message will appear stating 'Please remove USB Stick. System is shutting down.'

Remove the USB Memory Stick from the USB slot in the centre console storage compartment.

CARE POINT: The Nissan Connect screen may remain on this particular screen for up to 5 minutes. This is normal - do not alter the ignition position.

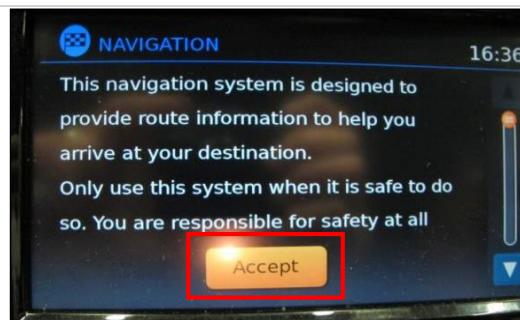
- 16 The Nissan Connect screen will go blank and then reboot. When the rebooting process completes the Nissan Logo will appear.

The standard navigation usage guideline message may appear. Press the 'Accept' button on the Nissan Connect screen.

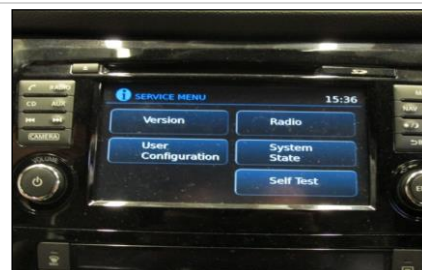
The software version should now be confirmed. Press and hold the 'Setup' button and then turn the 'Enter' button a half turn anti-clockwise, then a half turn clockwise, then a half turn anti-clockwise. The 'Service Menu' will then appear. Release the 'Setup' button.

Press and hold down the 'Setup' Button

- i) Turn anti clockwise by a half turn
- ii) Turn clockwise by a half turn
- iii) Turn anti-clockwise by a half turn

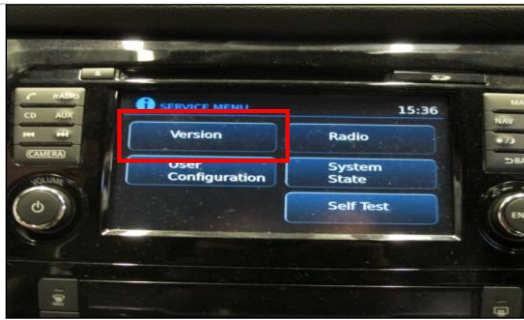
- 18 Press the 'Version' button on the Nissan Connect screen.
The 'Service Version' screen will appear. Ensure the software version is D502.

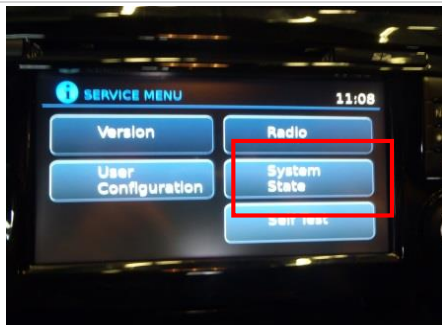
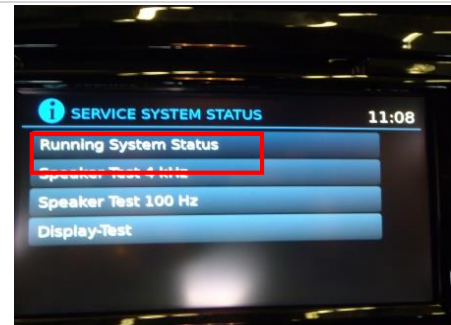
- 19 **Drive vehicle outside the workshop to an area where the sky is clearly visible.**
Press "back" button on audio unit and the 'Service Menu' screen will appear. Select system state.
The "service system status" screen will appear. Select "running system status".

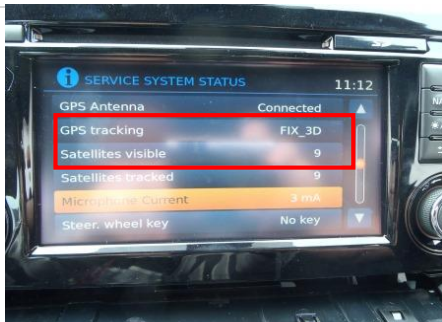
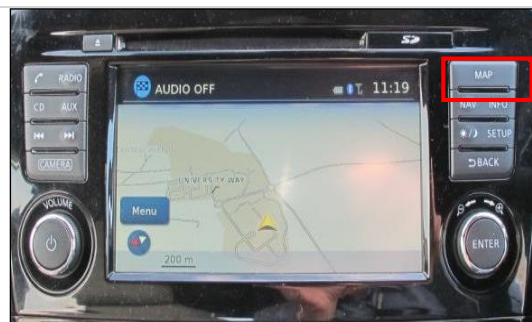
- 20 Scroll system status screen down until both GPS tracking and satellite visible are displayed. The screen should indicate:-
GPS tracking = FIX-3D and at least 4 satellites visible.
Press the 'MAP' button to return to the normal operating screen and confirm the map view is showing and functioning correctly.

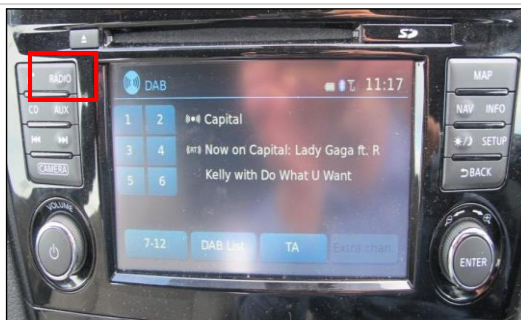
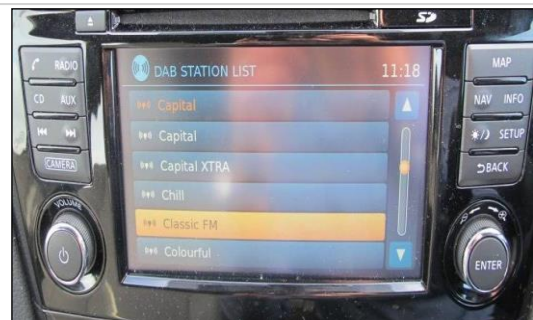
- 21 Press the 'Radio' button to ensure the radio activates and sound is generated through the speakers. Select 3 or 4 radio stations from the list to ensure these radio stations work as expected.

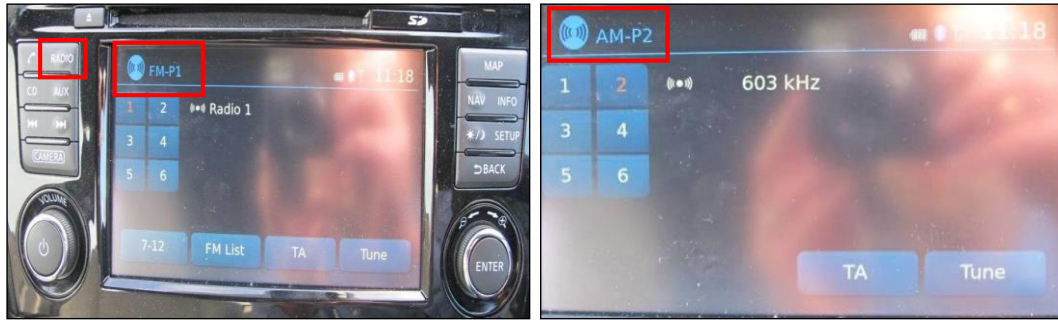
- 22 Press the 'Radio' button again to check the next radio band. Select 3 or 4 radio stations from the list to ensure these radio stations work as expected.

Repeat this process until all radio bands are checked (DAB, FM and AM).

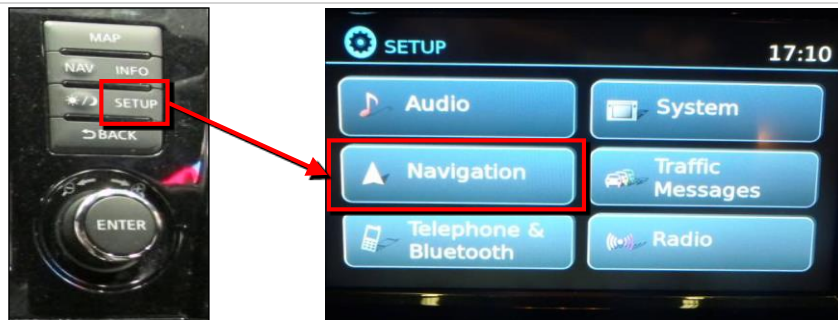
- 24 Click on the 'Setup' button and then press 'Navigation'.
