Product Campaign Bulletin

REFERENCE: PCB-NES-16-050

MODEL: Qashqai (J11) Juke (F15) Pulsar (C13)

SUBJECT: PCB J11 - PG6BP PS6B8 PR6B6 - Oil Usage ECU Reprogram

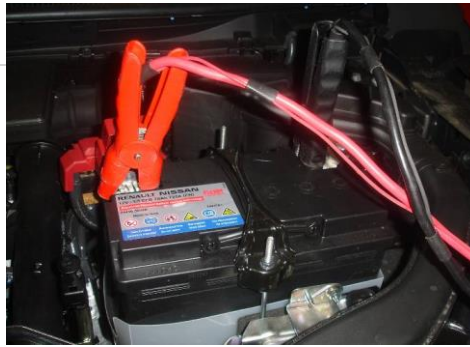
- 1 Connect 12V battery charger/stabilizer to the vehicle battery.
NOTE: Make sure all the key points in the precautions section are followed.

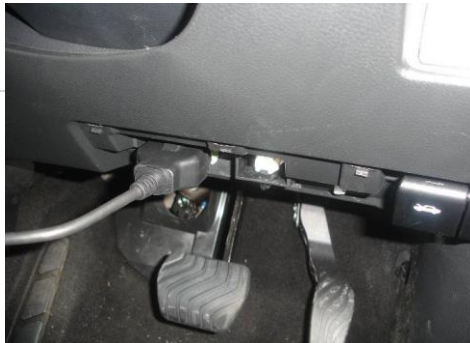
- 2 Connect the VI Unit to the vehicle OBD port and to Consult IIIplus using USB connection.

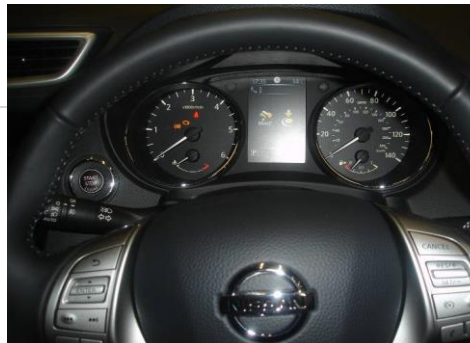
- 3 Change the vehicle condition to "ON", by operating the ignition switch or using the key.

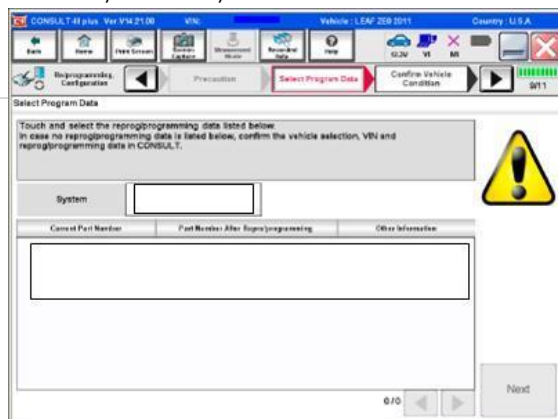
No option is shown for reprogramming or the reprogramming button is not active

Make sure the reprogramming patch has been correctly installed following the instructions at the end of the procedure. Make sure the Part Number of the unit is affected by the activity.

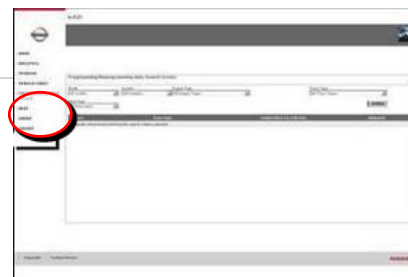
- 1 Log into N-FIT on the B2B portal, then select the Programming data search option in the left window pane .
